CONNECTICUT COASTAL BASIN  
WEST HAVEN, CONNECTICUT  
**MALTBY LAKE DAM No. 1**  
**CT 00111**

PHASE I INSPECTION REPORT  
NATIONAL DAM INSPECTION PROGRAM

AUGUST, 1979

### MALTBY LAKE DAM NO. 1

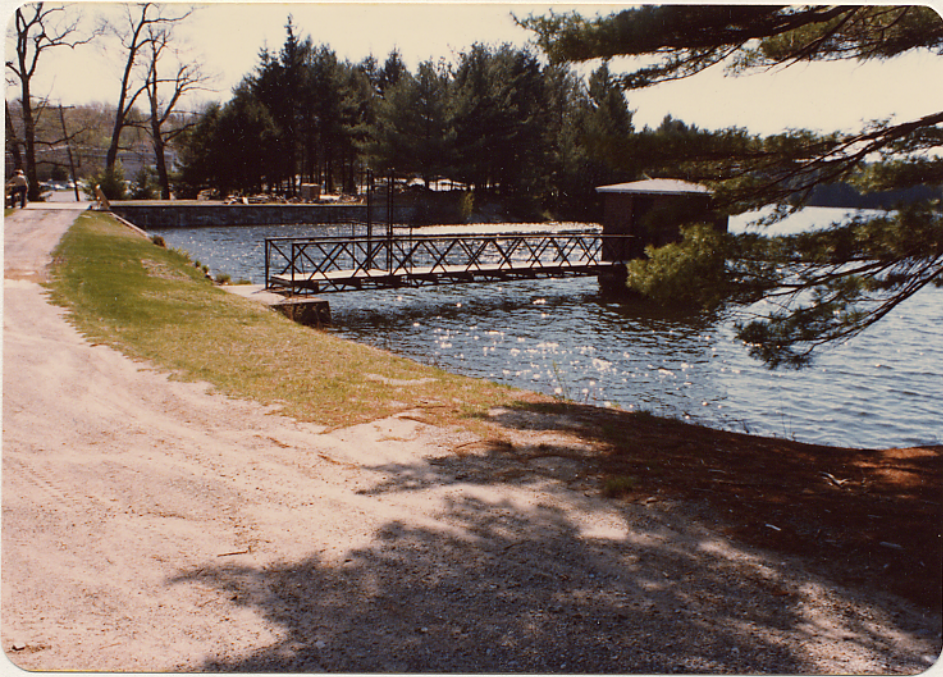
b. Dam Crest - The crest of the dam has a grass cover with a service road along its center line (Photo 1). The downstream portion of the crest is an 8 foot wide stone masonry section (Photo 2). No misalignment, depressions or cracks were observed along the dam crest. There was a low swale area on the natural ridge approximately 265 feet to the right of the spillway, which at elevation 136.4, would allow water from the reservoir to overflow 0.9 feet before the lake level reaches the top of the dam.

c. Appurtenant Structures - The concrete chamber of the upper gatehouse has no signs of visible cracks or spalling (Photo 1). No substantial rusting was observed on the metal service bridge.

PHOTO 1 - Upstream face of dam as seen from left abutment.  
Note intake structure and metal service bridge.

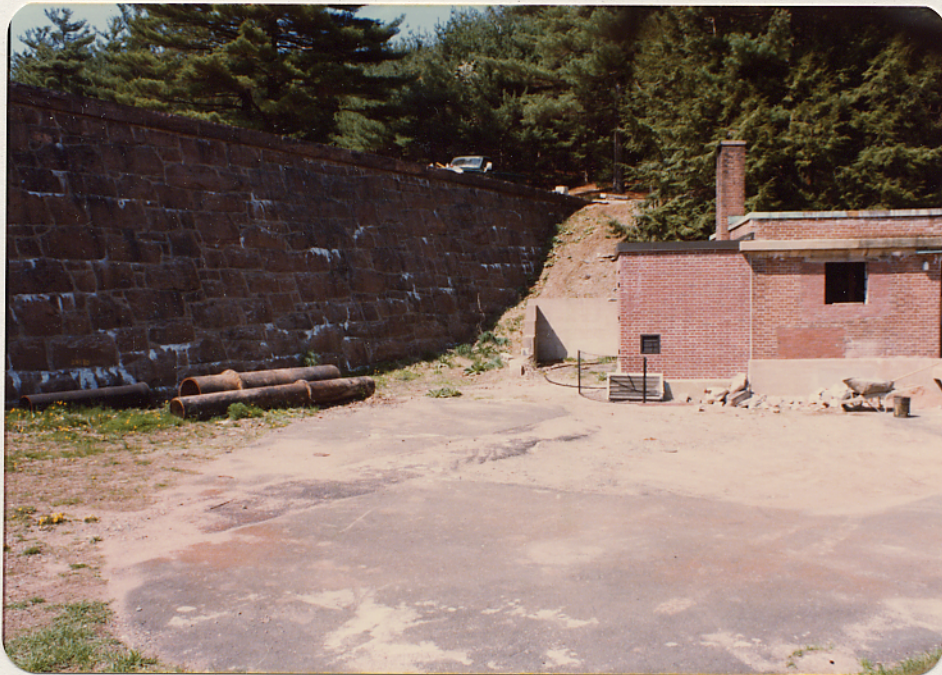
Downstream Slope - The downstream slope of the dam is the rubble masonry gravity section with a downstream face inclination of 1 horizontal to 3 vertical. The vertical upstream face of the masonry section was covered with a cement mortar coating and then had two coats of Portland cement grout brushed on when constructed. The downstream masonry face of the dam has some minor cracks along masonry joints with evidence of lime efflorescence (Photo 2). Some vines were observed on the lower portion of the slope. There are areas of runoff erosion along the toe of the left abutment where there is no erosion protection (Photo 2). The downstream slope of the earth embankment to the right of the spillway is steep and covered with wood chips for erosion protection (Photo 3). It was not apparent whether this area was a portion of the dam, and it showed no signs of erosion or instability.

PHOTO 2 - Left abutment and downstream face of dam.  
Note efflorescence from stone block masonry.

7. Erosion of the downstream face of the left abutment should be repaired, and the appropriate measures taken to prevent further erosion.

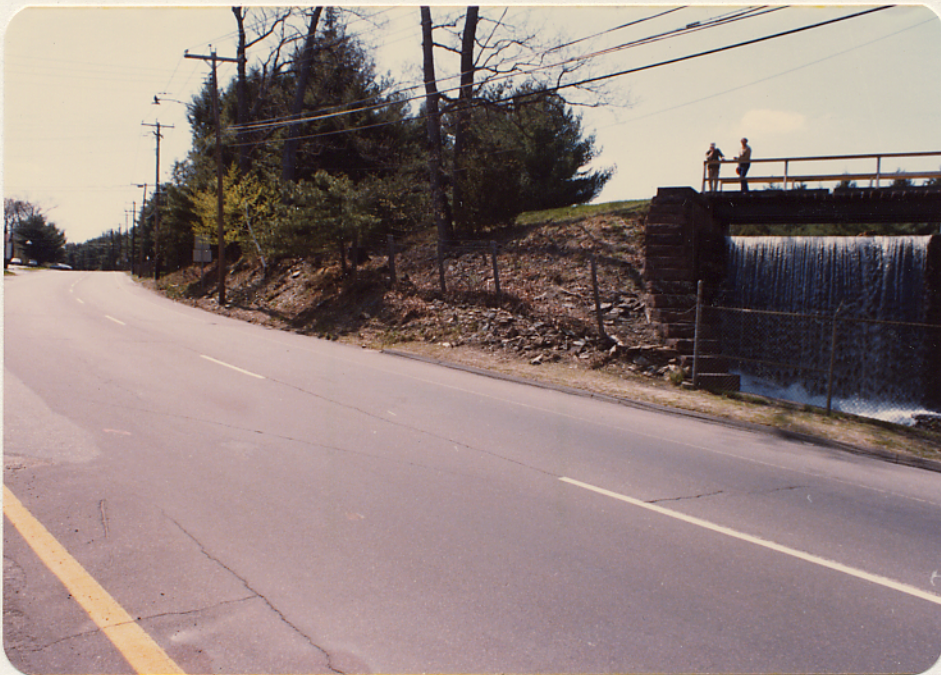
Spillway - The 21.5 foot long spillway is a stone masonry broad-crested rectangular weir with 4 feet of freeboard between its crest and the top of the dam. The spillway is spanned by a bridge which has a 2.8 foot high clearance from the top of the weir (Photo 3). The spillway is generally in good condition. Some minor deterioration was observed on the downstream wingwalls. The dam operator said there are several seepage spots on the spillway face which can be seen during the dry season. Some leakage at the spillway base was noted also by maintenance personnel in May, 1964 according to existing correspondence. During a preliminary inspection performed on April 17, 1979, at a time when water was not flowing over the spillway, we observed seepage in two

places immediately adjacent downstream of the weir. Seepage was emanating from the right training wall at the bedrock interface, and on the left training wall from the mortar joints between two stone blocks. Seepage flow observed was minor, but steady.

PHOTO 3 - Right abutment and spillway crest.

2. The seepage from the spillway face and spillway channel walls should be monitored periodically for any change in the condition.
3. Vegetation, such as vines, at the downstream slope of the masonry section should be removed to avoid deterioration of the masonry.
4. Surface erosion along the downstream face of the left abutment should be repaired to prevent further, more serious erosion.
5. With the low level outlet pipes gated on the downstream side of the dam, the conduits through the dam are under constant head. This situation is not desirable, and in the future should repair or redesign of the hydraulic facilities take place, consideration should be given to the installation of gates on the upstream side of the dam.

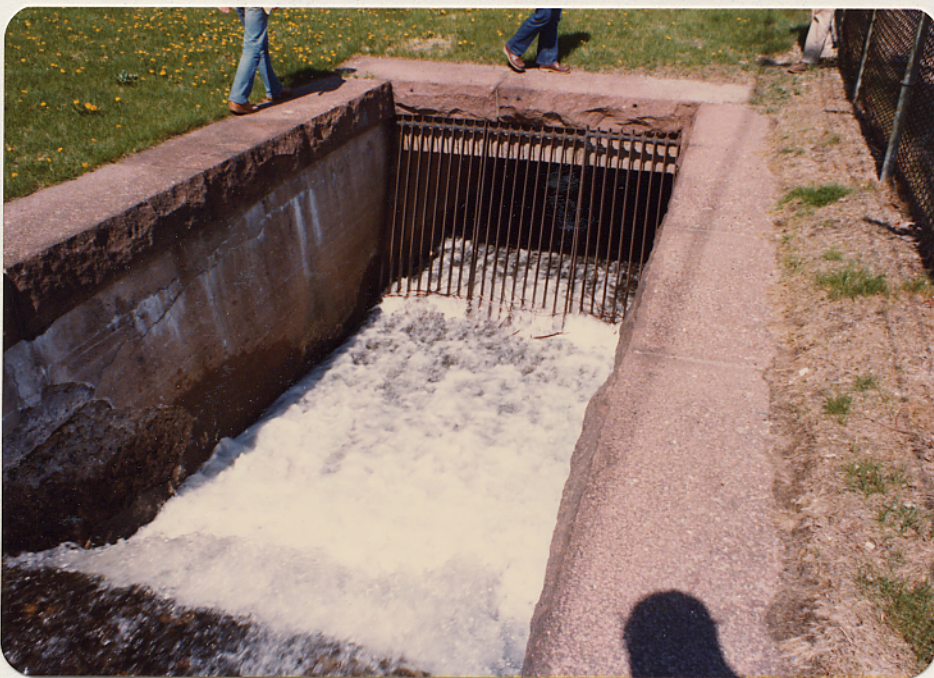
The spillway discharge channel is a 10 foot wide and 3 foot deep open trough with concrete stone coping walls, and leads to a concrete arch culvert under Connecticut Route 34 immediately downstream. Some cracking and spalling of the concrete was observed at the left wall of the channel (Photo 4).

PHOTO 4 - Entrance to culvert under road located near toe of dam. Note cracking and spalling of sides of concrete spillway channel.

1. The deteriorated masonry and concrete surfaces of the spillway and the spillway discharge channel should be repaired to prevent their further deterioration.

4. The cracking and spalling of the concrete and masonry of the gravity section of the dam, the downstream face of the spillway and the spillway diversion channel walls should be repaired.
